SEISMIC HAZARD EVALUATION

RANCHO PALOS VERDES CIVIC CENTER BUILDINGS

30940 HAWTHORNE BOULEVARD
RANCHO PALOS VERDES
CALIFORNIA 90275

BREIHZOLZ QAZI ENGINEERING, INC.
1852 Lomita Blvd., Suite 210, Lomita, California 90717
EMAIL: engineer@bqe.com <http://www.bqeinc.com/>
TEL: 310-530-3050 FAX: 310-530-0184
Project 2K-027Q October 25, 2000

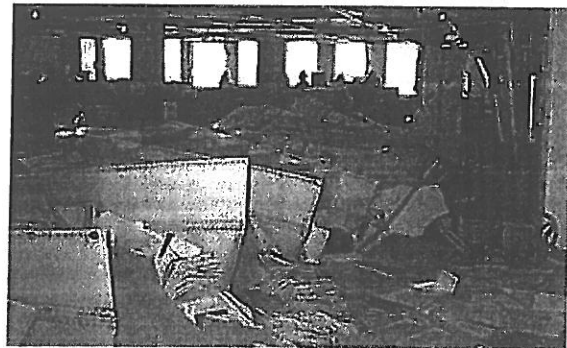
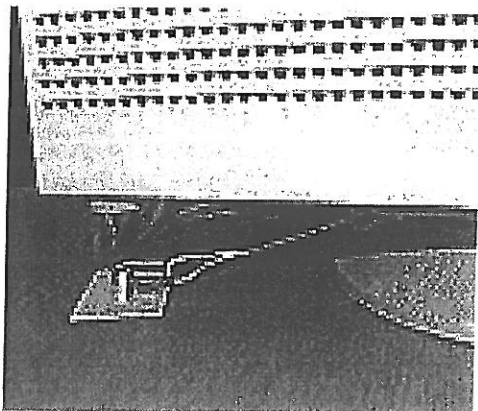
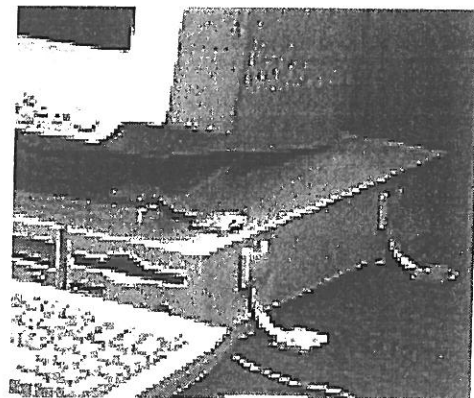
The above pictures show the top of filing cabinets and/or bookcases anchored to adjacent walls. This type of anchorage can also be applied to other tall furniture in the building. Tall furniture is likely to overturn during a major earthquake. Desktop computers may move during a major earthquake but these are not likely to fall down from desks. Computer anchorage shown on the pictures below is only recommended for critical computer equipment such as computer servers. The suspended ceiling system in the building is not expected to suffer extensive damage. The partition walls for the offices divide the ceiling into numerous sections that are actually confined by the walls. The picture to the left shows extensive damage from overturn filing cabinets and bookcases.
